# WOODWORMED TIMBER

Some timber varieties may feature galleries (in the form of small holes) of varying sizes (3 to 16 mm in diameter), which are said to be «woodwormed».

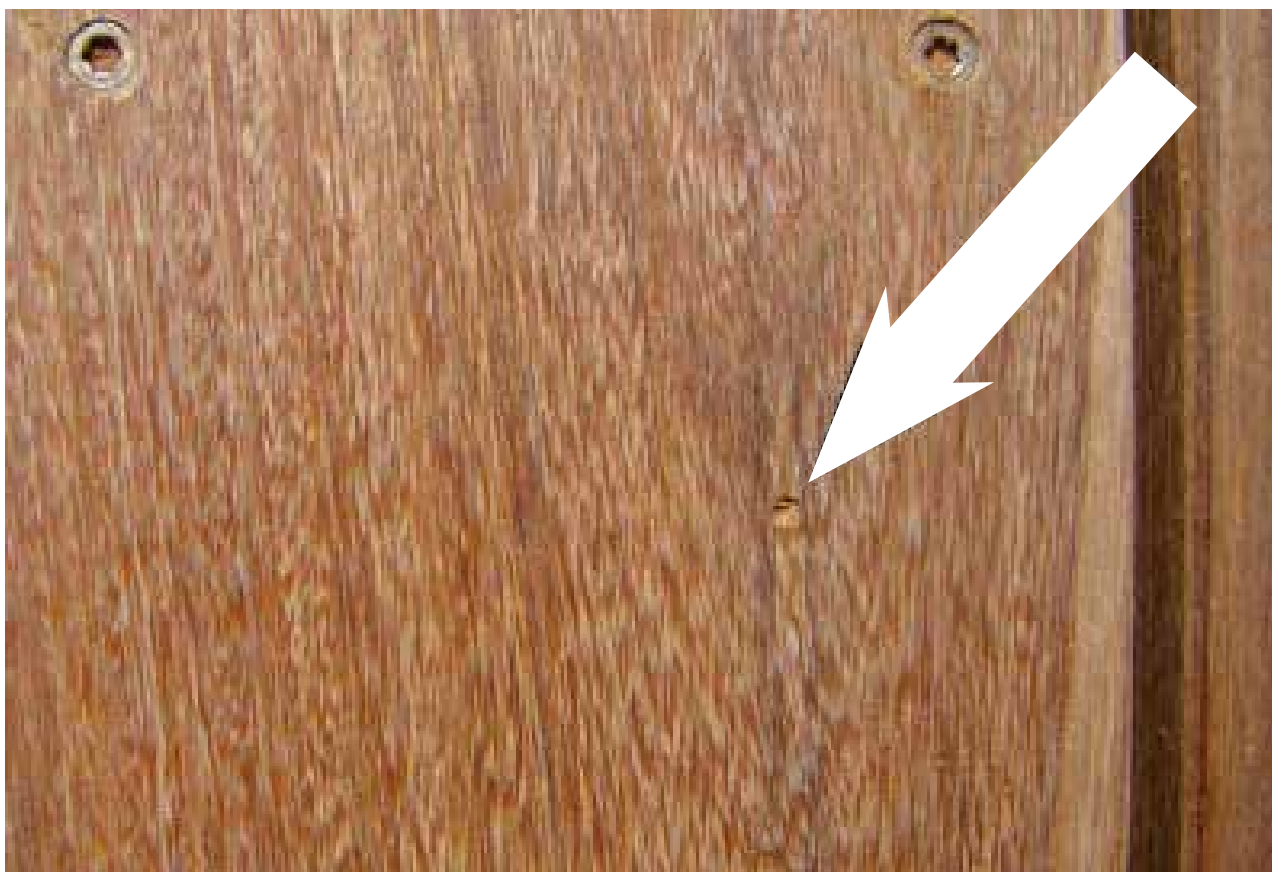
### Example of a perforation that is barely visible because it is still obstructed:

The sometimes «late» and gradual appearance of the perforations has a simple explanation: the excrement and sawdust emitted by these timber borers often form a natural plug, or «putty», that will effectively block the hole in a durable manner. **Some insects voluntarily obstruct the galleries with these «plugs» in order to protect their egg-laying from external predators.**
